U.S. Air Force Airfield Damage Repair (ADR) Modernization Program

Evaluation of Flowable Fill Surface Performance

November 2016

Final report

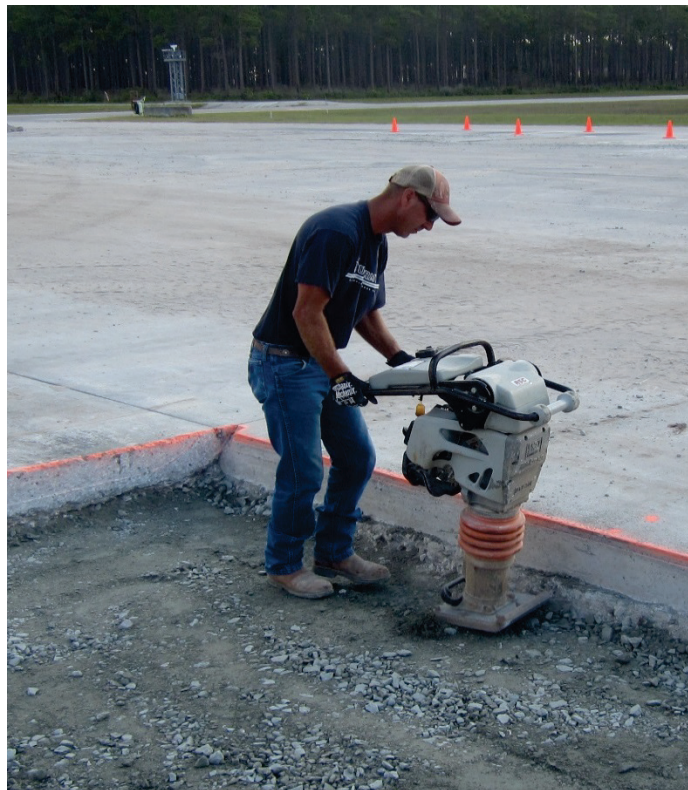
Figure 4. Multiquip Mikasa MTX-70 rammer-style compactor.

A small rammer-style compactor was used to compact the natural subgrade, sand backfill, and crushed stone backfill material during testing. The compactor used was a Multiquip Mikasa MTX-70 (Figure 4), which has a 2.8-hp motor capable of providing 3,350 lbf of impact force. Additional specifications are displayed in Table 5. The small rammer-style compactor was used, since larger compaction equipment would be difficult to maneuver inside small craters. In addition, the smaller rammer-style compactor eliminates the logistical burden of deploying larger compaction equipment.

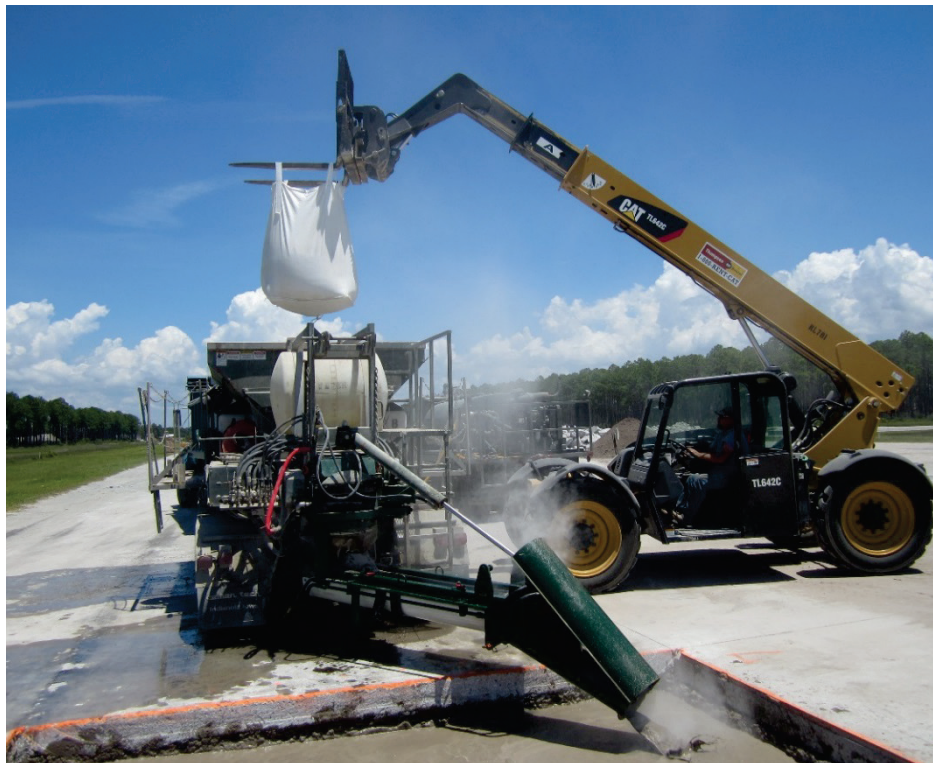
Figure 5. Extendable-boom forklift loading supersack into volumetric mixer.

An extendable-boom forklift was used to move the 3,000-lb supersacks of pre-blended flowable fill materials. The extendable boom was a Caterpillar TL642 telescopic forklift, which was capable of lifting 6,500 lb and extending 30 ft. The extendable boom is needed so that the large supersacks of flowable fill can be loaded into the simplified volumetric concrete mixer, as shown in Figure 5.

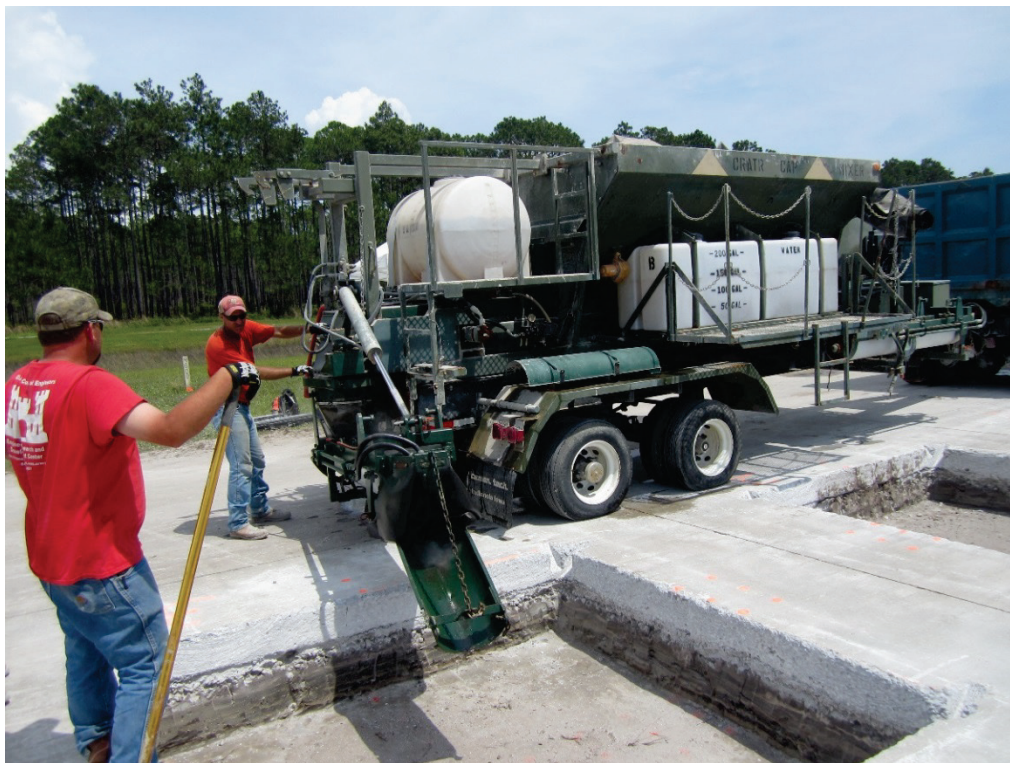
Figure 6. Simplified volumetric mixer.

A specially designed tow-behind simplified volumetric concrete mixer (Figure 6) was previously designed by CemenTech Inc. in consultation with the ERDC for use in the ADR modernization program. The simplified volumetric mixer is pre-calibrated for rapid-setting cementitious repair materials to include flowable fill and concrete capping material.

positive displacement water pump to meter mix water according to a fixed pump speed, two 200-gal water tanks on each side of the mixer, a washout tank with pressure washer, and a replaceable mixing auger mounted in a discharge boom at the rear of the machine. The machine is outfitted with two retractable catwalk platforms, a bin entry platform, a replacement auger, and two super sack piercing points. The only means of controlling the water-cement (w/c) ratio is by adjusting a strike-off gate, which can change the height of the dry material on the conveyor belt feeding the mix auger. Allowing more dry material to enter the mix auger results in a mix with a lower w/c ratio. The wheel for adjusting the gate height has a scale from 1 to 12, where 1 allows the least amount of material to enter the mix auger and 12 allows the most. However, typical strike-off gate settings used during production of rapid-setting flowable fill or rapid-setting concrete range from 4 to 8.

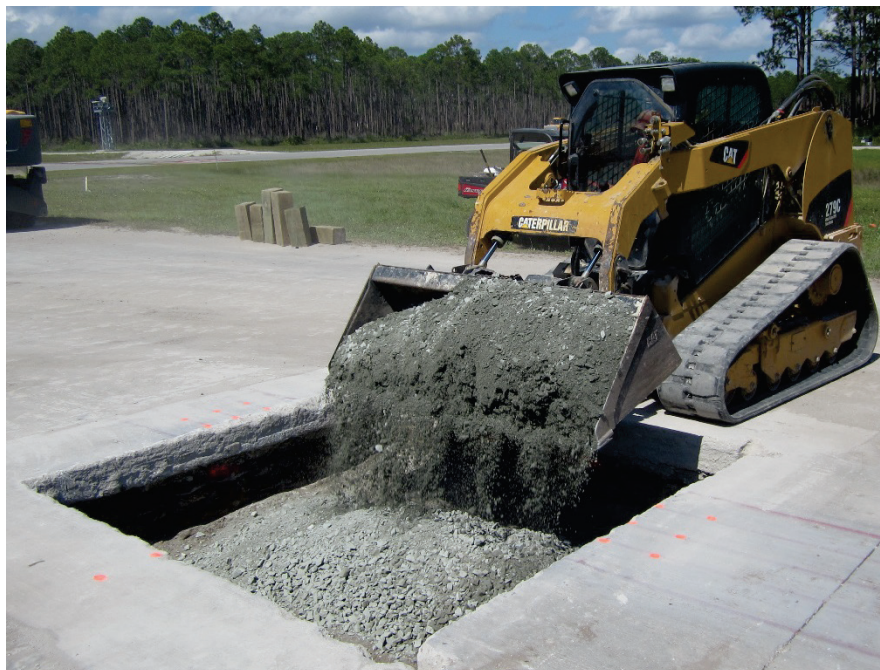
Figure 7. Crushed stone limestone backfill.

Crushed limestone (Figure 7) purchased from a local vendor was used as a backfill material for some test craters. Crushed limestone was selected because it can be available on some U.S. Air Force (USAF) airfields that have access to higher quality materials. The maximum aggregate size of the material was approximately 1 in. The USCS classification of the material was a well-graded gravel with silt and sand (GW-GM). The fines within the crushed limestone were non-plastic.

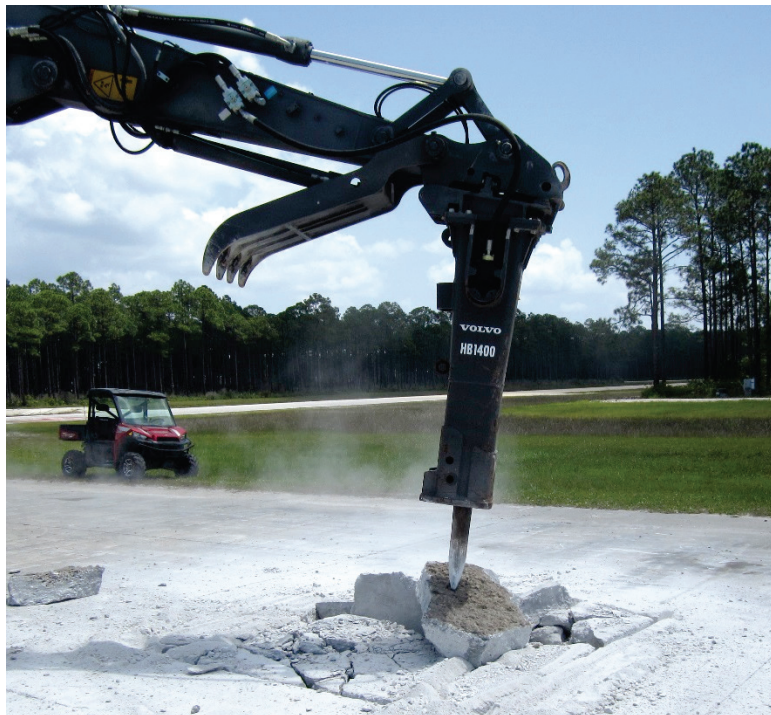
Figure 10. Breaking using Volvo HB 1400 breaker attachment.

For marking, the target size of the finished crater repair (8.5 ft by 8.5 ft or 15 ft by 15 ft) was measured and marked with a string line and marking paint. Since no upheaval was present, stanchions were not used in the marking process. Saw cutting was conducted using the CTL with a wheel saw attachment. For breaking and excavating, a Volvo EWC-30 wheeled excavator with the appropriate attachment (hammer or bucket) was used. A small mini-excavator was also used in some instances to remove material along the walls of the excavation. In an actual crater repair scenario, this type of fine excavation would not be conducted. However, since the thicknesses of each layer of the crater repair structure was important to the objective of the project, a tolerance of ± 0.5 in. was imposed. Figure 9, Figure 10, and Figure 11 show the saw-cutting, breaking, and excavating processes, respectively. Figure 12 shows an excavated 8.5-ft by 8.5-ft crater, and Figure 13 displays an excavated 15-ft by 15-ft crater.

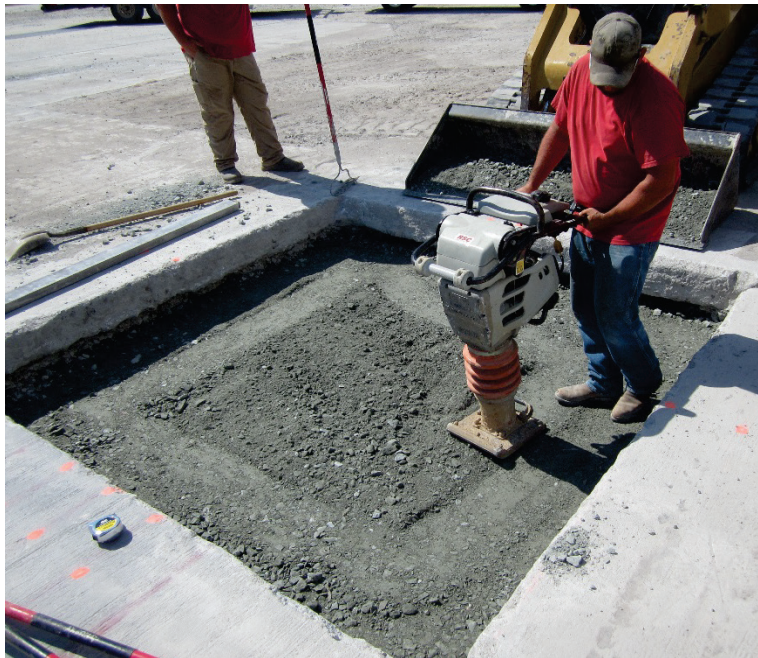
Figure 15. Compaction of crushed stone backfill material.

Backfill materials were placed in two separate lifts, each one approximately half of the total target thickness, with a maximum lift thickness of 6 in. The CTL and hand tools were used to place and level the material. Two coverages of compaction with the rammer-style compactor were applied, and any remaining areas of loose material were also compacted. A small amount of water was added to the masonry sand to aid compaction. Figure 15 shows compaction of the crushed stone backfill material.

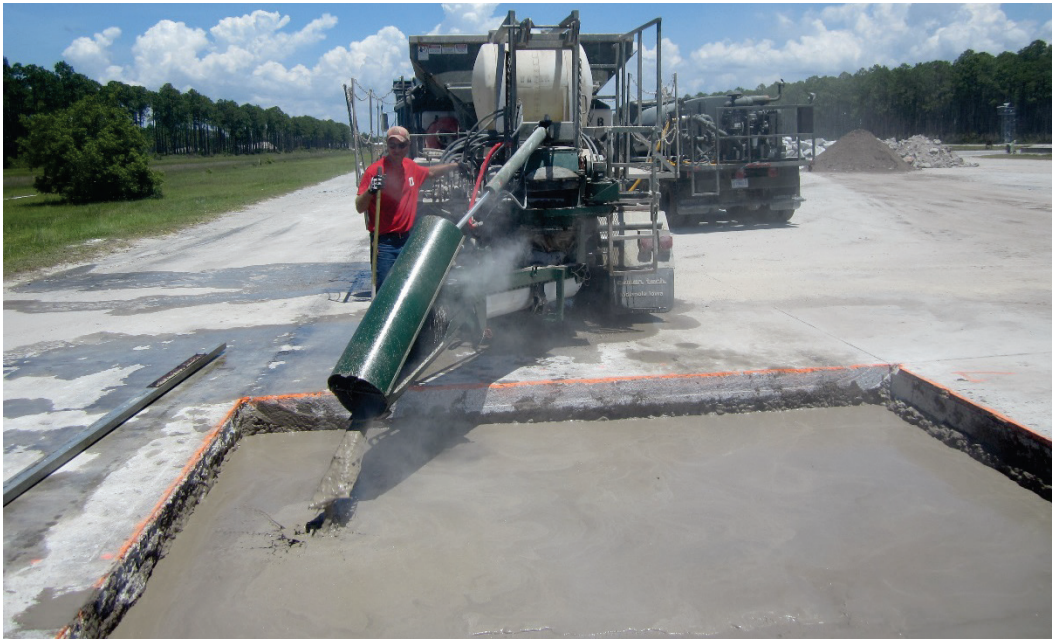
Figure 16. Rapid-setting flowable fill placement during a large crater repair.

During the test, the rapid-setting flowable fill supersacks were continuously loaded into the volumetric mixer, and the mix water tanks were refilled as needed. No chemical additives of any kind were used during testing, since additives are not typically used when rapid-setting flowable fill is used as a backfill in the crater repair process. Figure 16 shows placement of rapid-setting flowable fill during a large crater repair. As shown, one extension chute was used for large crater repairs. Instead of moving the tow vehicle forward and backward to placement material in different areas of the repair, the extension chute was extended or retracted as needed. Once enough material was placed into the excavation, the crater repair cap was struck off with a magnesium screed bar (Figure 17). A 12-ft-long and 20-ft-long screed bar was used for the small and large craters, respectively. While the material was still workable, the surface was screeded multiple times, particularly for

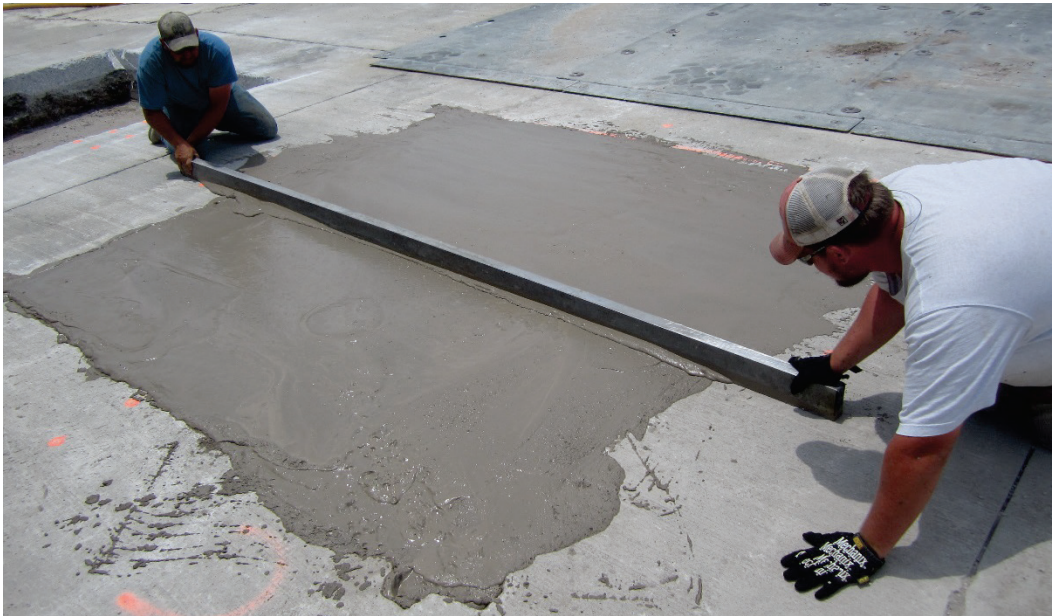
Figure 17. Screeding of rapid-setting flowable fill cap.

the small craters, to ensure the surface was as smooth as possible and matched the elevation of the surrounding pavement. Flat shovels and steel trowels were used to clean the edges of the repair.

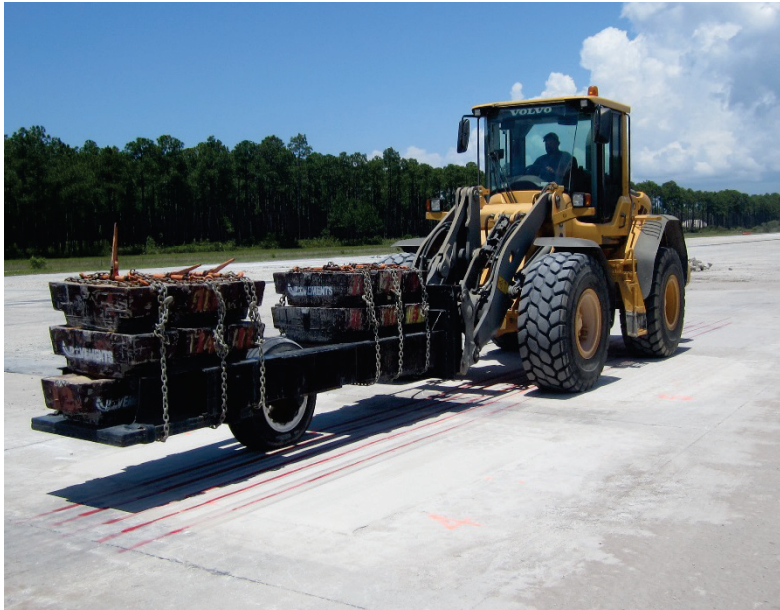
Figure 18. F-15E load cart.

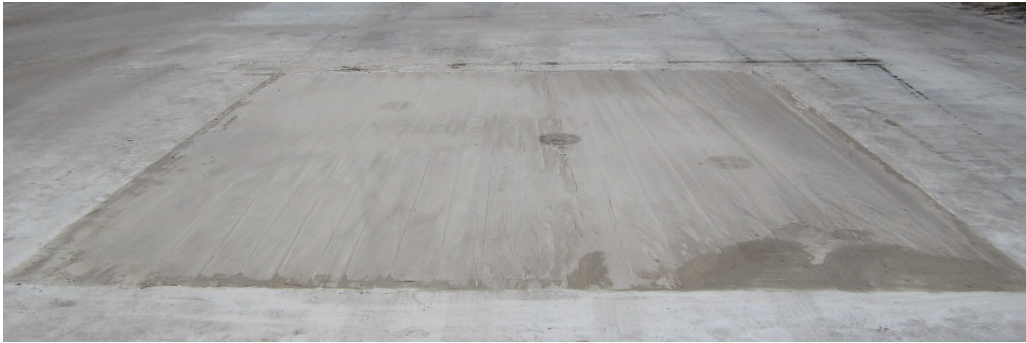
Figure 26. Crater 7 before trafficking.

Figure 26 shows Crater 7 before trafficking. Some minor surface deficiencies were visible near the edge of the crater, but no cracking was observed. A photo of Crater 8 before trafficking is shown in Figure 27. An inset in Figure 27 shows a 0.5-in. deep depression that was created during heavy-weight deflector (HWD) testing. Upon further investigation, it was concluded that this test location was a very isolated area of weaker material, since the other two HWD tests on the repair did not result in any depressions. This conclusion was confirmed during trafficking.

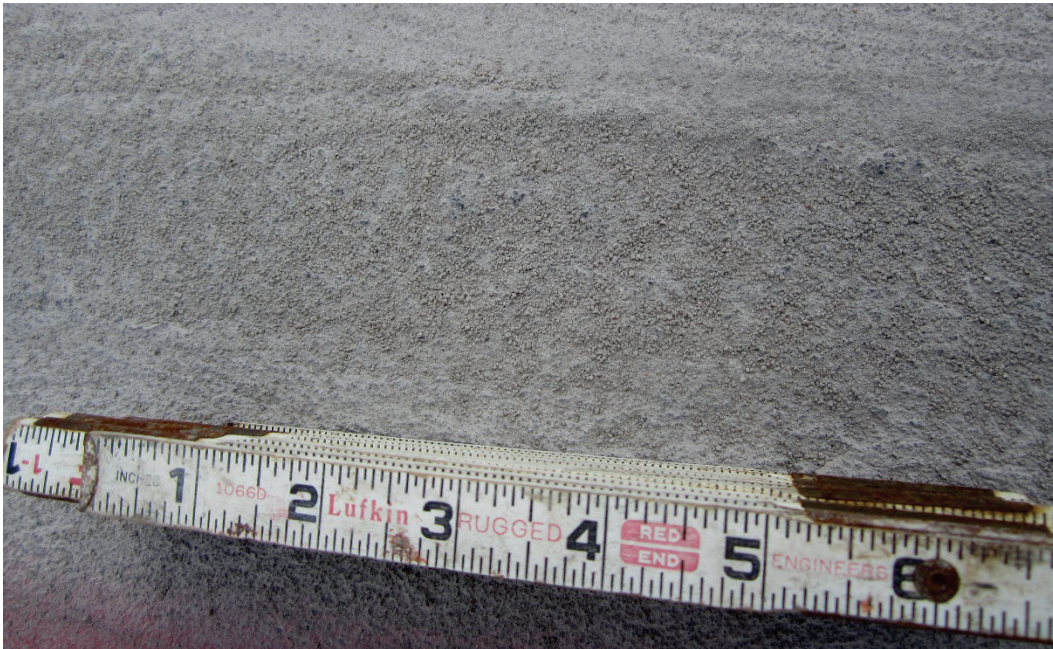
Figure 29. Closeup of small debris on Crater 1 after 112 passes.

After the initial 112 passes (7 complete patterns) were applied to Craters 1, 2, and 3, the craters were again visually examined for damage. Figure 28 shows Crater 1 after 112 passes. The only visible distress was a considerable amount of very small debris (Figure 29). The small debris is discussed further in the next section.

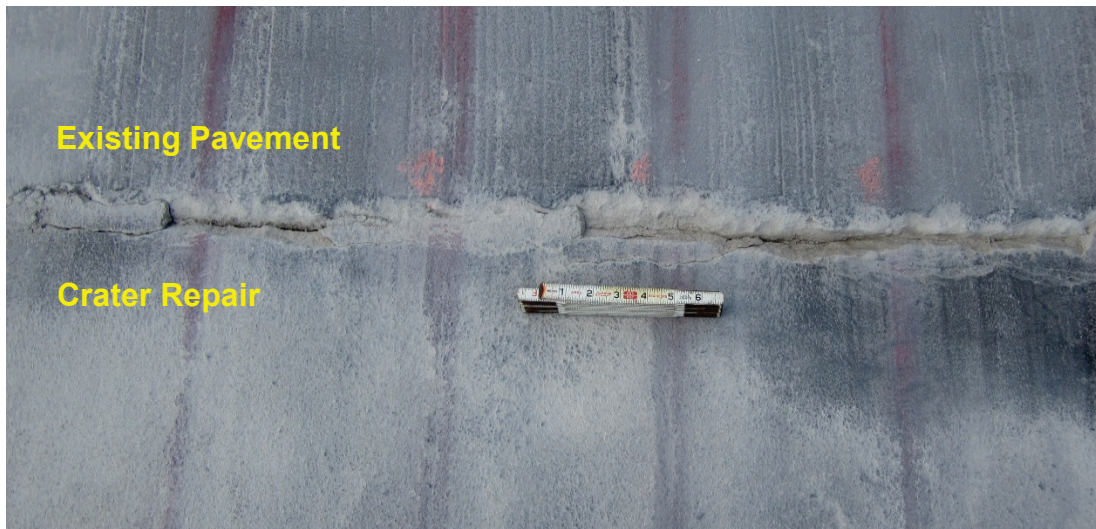
Figure 35. Crater 2, 512 passes, high-severity joint spalling.

After 512 passes, several notable distresses became apparent. As shown in Figure 34, Crater 1 exhibited medium-severity joint spalling with a high foreign object debris (FOD) potential on the south edge of the repair. Figure 35 shows high-severity joint spalling on the south edge of Crater 2. Some FOD was observed outside the crater and the depth of the spall measured approximately 1 in. The distresses for Crater 3 were less severe; only a depression and medium-severity spalling were observed (Figure 36). Due to the tire hazard created by the high-severity joint spalling, Crater 2 was considered failed. Since Craters 1, 2, and 3 were to be excavated so that Crater repairs 4, 5, and 6 could be constructed, trafficking of Craters 1 and 3 was also ceased.

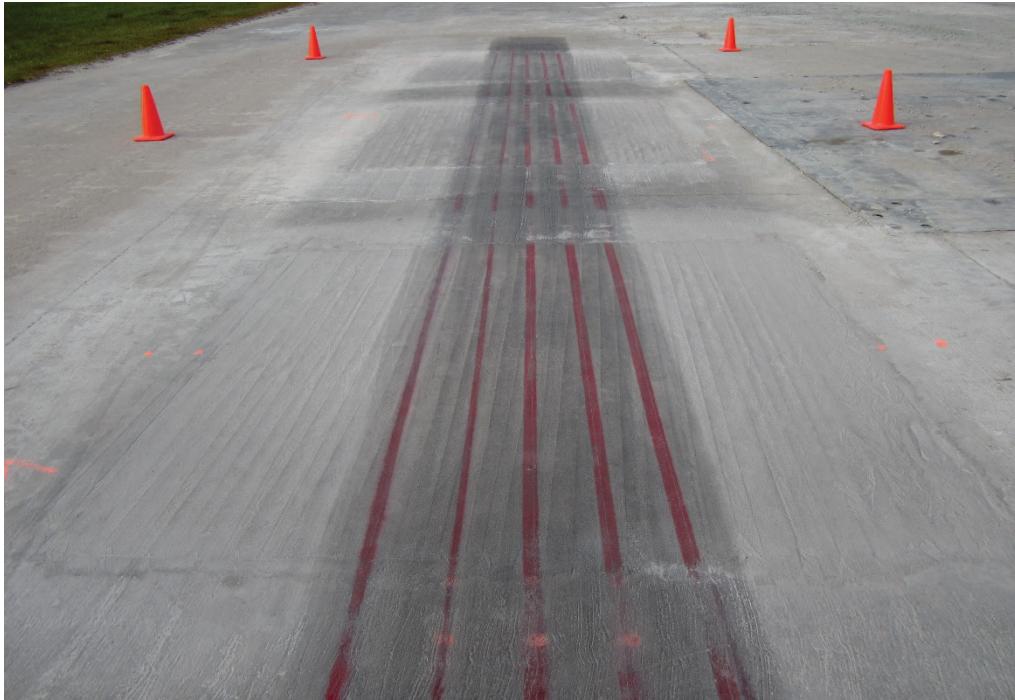
Figure 38. Craters 4, 5, and 6, 512 passes, overall.

After Craters 1, 2, and 3 were excavated and Crater repairs 4, 5, and 6 were constructed, trafficking commenced. Each repair was inspected every 112 passes; however, no distresses were noted, and much less small debris was observed compared to Craters 1, 2, and 3. Figure 37 shows debris accumulating on Crater 4 after 112 passes. Craters 5 and 6 showed a smaller amount of debris compared to Crater 4. Trafficking was ceased at 512 passes due to limited time on the test site, but no notable distresses were observed. Figure 38 shows an overall photograph of Craters 4, 5, and 6 after 512 passes. The reduction in distresses could be due to a slight decrease in the w/c ratio that was implemented for Craters 4, 5, and 6 and discussed previously in Section 3.3.
